**Rich Hill Farmhouse
Historic Structures Report
Bel Alton
Charles County, Maryland**

The Ottery Group, Inc.
3910 Knowles Avenue
Kensington, Maryland 20895

May 2016

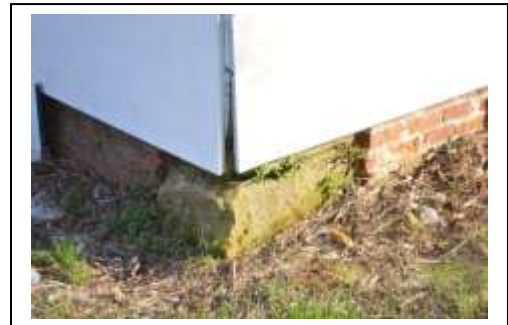
The house appears to have originally been set solely on quarried sandstone block piers. There are also two concrete or perhaps parged stone piers present on each corner of the front of the building. Later brick infill now encloses nearly the entire foundation perimeter and likely adds support to the framing members. Some of this brick infill was present in the nineteenth century and some appears to be of twentieth century origin.

South Corner Sandstone Blocks and Brick Infill.

The foundation appeared to be generally in fair condition. Piers visible from the exterior of the house were intact. Brick infill had some loss of mortar.

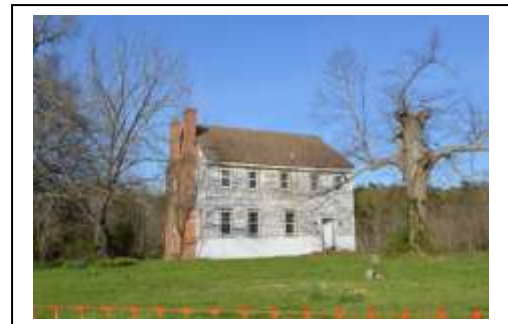
Southwest Façade (Front Façade).

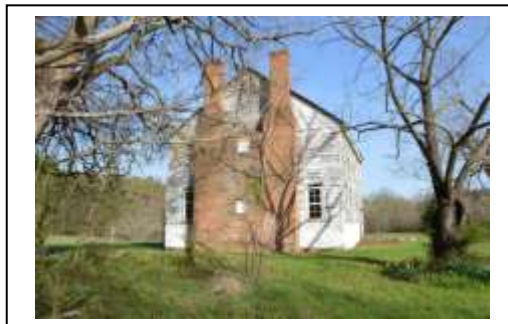
Northwest Gable End Chimney.

The chimney is in poor condition. It has large diagonal cracks that are visible from the interior of the closets adjacent to the chimney. A large lower part of the chimney exterior has been re-pointed with incompatible mortar that is too hard for the surrounding brick. Brick on the north (rear) entrance has deteriorated and presents a tripping hazard.

- 2: Install crack monitors on the chimney.
- 3: Correct site drainage ensuring that ground slopes away from the foundation to shed water.
- 4: Perform a complete structural conditions assessment to identify all issues that may impact the stability of the structure such as termite damage.
- 5: Monitor the structure on a regular basis not less than twice per year.
- 6: Restore the structure within the next five years. Additional measures may be needed to assure stability of the structure.

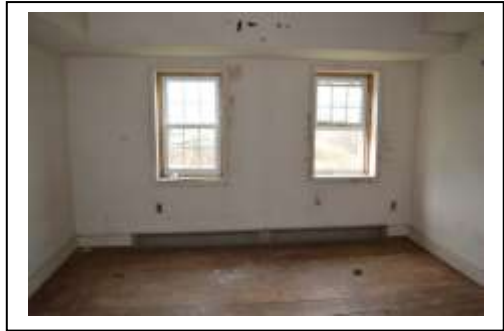
The wall and ceiling junctions of each of the four bedrooms on the second floor were originally vaulted. The ceiling corners were boxed in during the 1975 renovations with drywall. This drywall and modern framing was removed in late July of 2015. Now visible are original remnants of roof rafters that were once covered with lath and plaster on the front and rear sides of the house with matching smaller dimension boards on the other sides of the bedrooms, creating an unusual vaulted ceiling that sloped down to the walls on each side. Although the smaller vaulting boards have been removed from the center wall of each room, evidence by way of nail holes, remaining forged nails, wood and ghosts of plaster and lath lines remain.

West Corner Room Showing Boxed Ceiling.

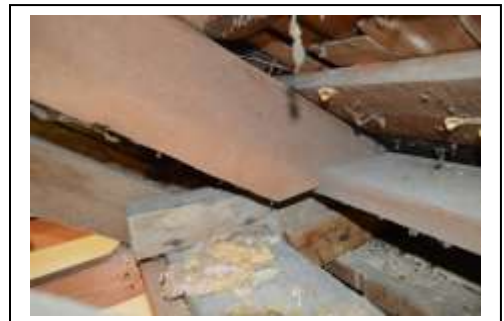
The present roof rafters appear to have been added during a later renovation. The lower portion of the original hewn rafters and original collar ties remain and continue to act as supports for the vaulted ceiling. At the south corner of the building, a single remaining section of a hip rafter remains in place with some connecting rafters intact. The outriggers and false plate may have once supported a flared roof configuration.

Roof Rafters and False Plate.

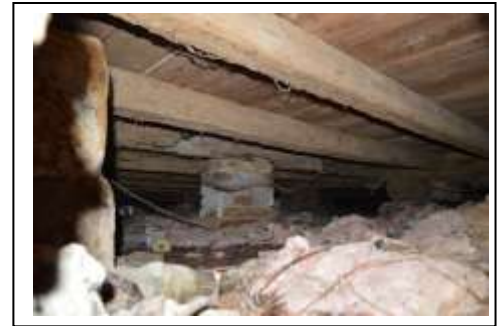
The original house was supported by various posts that supported the main sill plates. The National Register nomination form states that these were originally all sandstone piers, however, the visible piers include both cut stone and piers at the front corners that are either concrete or brick/stone piers parged with mortar. There are several piers beneath the house constructed of brick and mortar that are unevenly located. The central summer beam appears to be supported by sections of round logs. It is unclear what is under the logs, but it may be stone or wood members. All of the brick infill between the exterior piers is of late nineteenth or early twentieth century origin.

Sandstone Pier at Left, Brick at Center and Wood Log Support at Right.

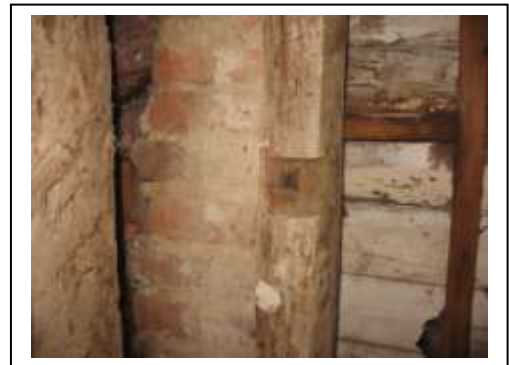
Evidence of Chimney and Mantle on Southeast Gable Wall.

There is evidence of possible chimney remains still present at the center of the southeast gable side of the house between the present two windows on the second floor. There is a remnant of brick that does not appear to be nogging, as all other nogging present within the walls have regularly spaced boards to help support the load of the brick, whereas, this band of brick does not have any wooden supports. This central area of brick is the only brick remaining within the walls on the southeast side of the house. There is also a notch with nail remnants suggesting that something wood was attached by joinery at a stud. This could have been part of a mantle. The idea of a chimney on this end matching the one at the opposite gable corresponds to an interview of Thomas Jones (foster brother of Samuel Cox) made in 1884 by George Alfred Townsend, reporter for *Century Magazine*. In that interview, Jones described the house as "a two-story house, with handsome piazzas front and rear, and a tall, windowless roof with double chimneys at both ends; and to the right of the house, which faced west (sic) was a long one story extension, used by Cox for his bedroom." He also described the house as having green shutters and a dark red roof (Townsend 1884).

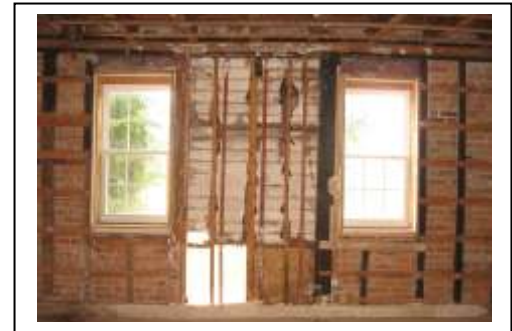
Recent examination of the original framing gives several strong points of evidence for the configuration of entrances. The framing at the central area of the front of the house shows no evidence of ever having had a doorway. Even where original studs are missing, there are evenly spaced mortises where framing members once existed between the central two windows in the main room. A cripple stud still remains at the top plate at this point. It appears to be at its original length, having a small bit of tenon remaining and forged nails. It is unsure what may have been at this location, given the mortise at the bottom plate, it would presumably have been a window and not a door. However, that would put a window very close to the others and would make as little sense as a door so close to the windows. Although no nogging is present between the windows today, there is some evidence of nogging having once been present at this location. Another possibility is that the mortise at the sill plate may have been a carpenter's mistake and that the mortise was not used.

Front Wall Framing.

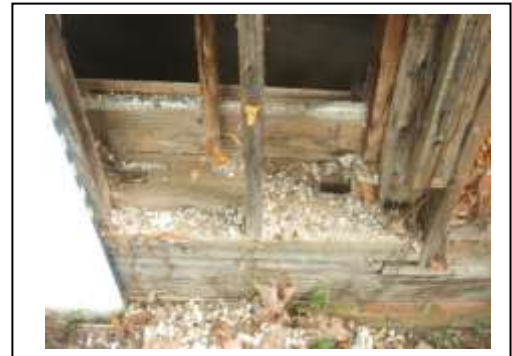
Mortise Joints on Front Sill Plate.

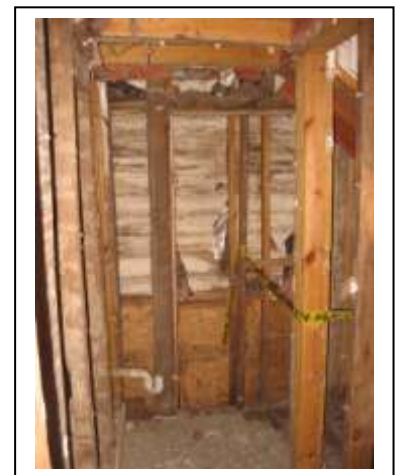
Within the center wall of the rear (northeast side) of the house, beneath the stairway, is a door frame that appears to date to the buildings original construction. This door opening was covered up during renovations in 1975. At the site of the present rear entrance at the rear end of the hall, an

Original Rear Entrance

original timber frame downbrace was cut to accommodate the door which serves as evidence that the door may have been moved to this location during the 1970s.

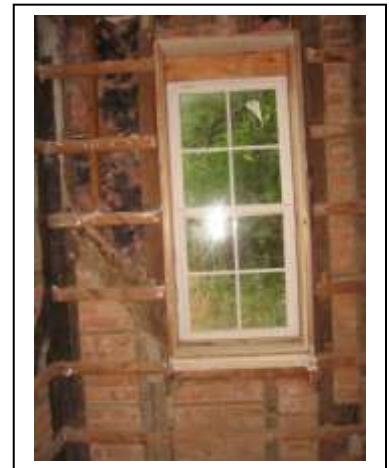
Although it has been suggested that the first floor window on the gable end nearest the west corner was not an original window location, the presence of nogging below and above the window framing and the existence of the original wood frame suggests that a window was originally at this location, albeit one of a different size. The downbrace that abruptly ends at the window does not appear to have been cut to accommodate an additional window, rather it appears to have been terminated purposely within a the jack stud. As the original nogging and framing are intact on the second story, no window ever existed at this location on the second floor. Historical photographs and framing evidence indicate that there were windows on both the first and second floor at the rear of the northwest side.

West Corner Gable Window.
