**Rich Hill Farmhouse
Historic Structures Report
Bel Alton
Charles County, Maryland**

The Ottery Group, Inc.
3910 Knowles Avenue
Kensington, Maryland 20895

May 2016

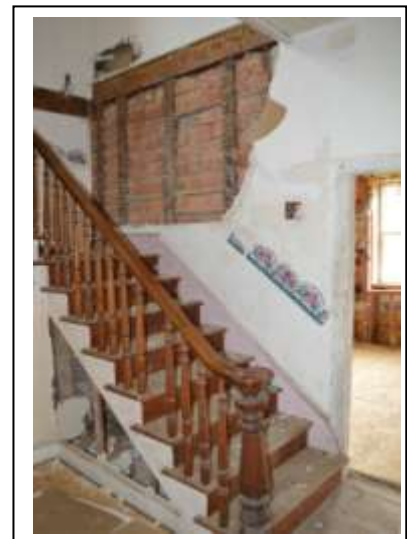
Stairs and Brick Nogging.

Tucked beneath the dog-leg stairway is a small water closet that was constructed in the 1970s. The stairs and railing appear to be later replacements from the mid nineteenth and were probably salvaged from another location. The railing has signs of being retrofitted to the staircase and the underside of the railing has numerous holes for balusters that do not line up with any existing balusters and in some cases, the existing

balusters utilized the nearest available hole which did not always lead to perfectly plumb balusters. Some early riven lath and plaster remains on the wall beneath the staircase. All principal exterior and interior walls on the first floor have original eighteenth century brick nogging between framing members.

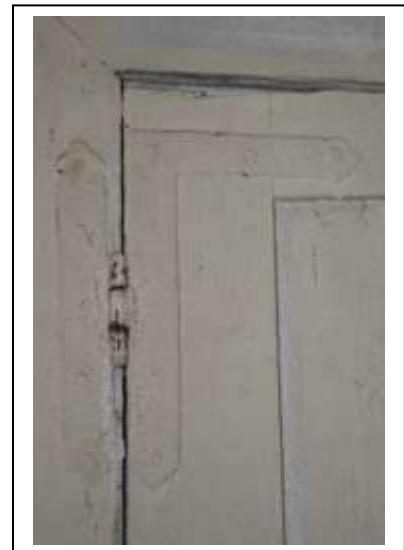
Wrought Door Hinge.

At the southwest end of the hall lies a small full bathroom that included a ca. 1975 toilet, bathtub and sink. The floor was covered with tile installed in the 1970s. Until its removal, the walls were clad with drywall, but the wall framing, including the interior wall of the bathroom appears to be chestnut with visible ghosts of removed lath. The door and door frame appear to date to the eighteenth century or at the latest, early nineteenth century. The door is identical to other original doors on this floor but it no longer has its wrought iron hinges.

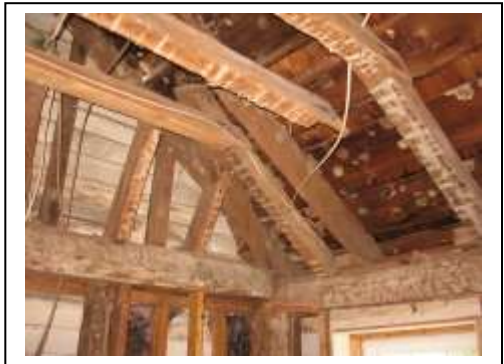
Vaulted Ceiling Frame Members.

A great deal of interest has been focused on the original configuration of the ceilings. Rivoire noted that the second story is not full height as the tops of the second story windows meet the wall top plate. The exterior gives the appearance of extra height due to the outriggers and false plates adding height to the roofline. The vaulted ceiling gave the interior full height. It is clear that the present roof rafters, which rest on a false plate that itself rests on outriggers, are pit-sawn (not circular sawn or axe-cut) and likely date to the late eighteenth or early nineteenth century renovations by either Rev. Richard Brown (1783), Samuel Cox or Hugh Cox (1820-1830). What appear to be the original hewn rafters resting on the hewn top plates were apparently cut even with collar ties during the change in the roof from hip to gable to preserve the original vaulted ceilings while making way for the updated gable roof members. The vaulted ceiling thus most likely dates to the 1730 period.

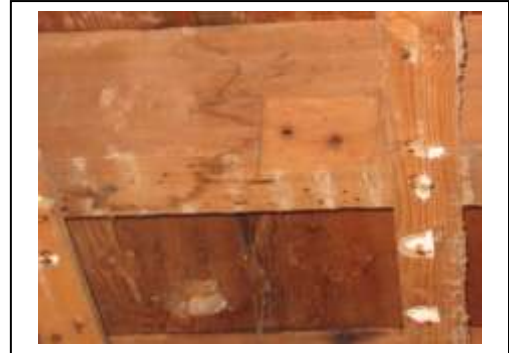
Joinery Evidence of Partition Wall.

Recent examination of the original framing gives several strong points of evidence for the configuration of entrances. The framing at the central area of the front of the house shows no evidence of ever having had a doorway. Even where original studs are missing, there are evenly spaced mortises where framing members once existed between the central two windows in the main room. A cripple stud still remains at the top plate at this point. It appears to be at its original length, having a small bit of tenon remaining and forged nails. It is unsure what may have been at this location, given the mortise at the bottom plate, it would presumably have been a window and not a door. However, that would put a window very close to the others and would make as little sense as a door so close to the windows. Although no nogging is present between the windows today, there is some evidence of nogging having once been present at this location. Another possibility is that the mortise at the sill plate may have been a carpenter's mistake and that the mortise was not used.
